NEW LOOK - 6 KING STREET, ST HELIER

CLIENT: NEW LOOK

CONTRACT ADMIN: ABS CONSULTANT LTD

ARCHITECT: ANTONY GIBB LTD

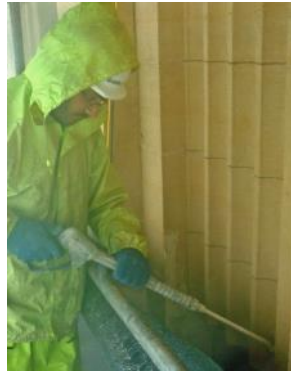
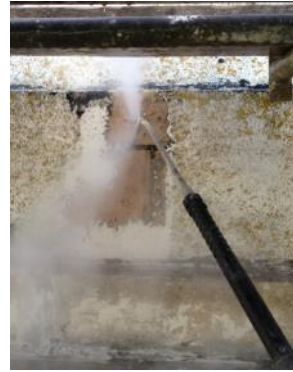
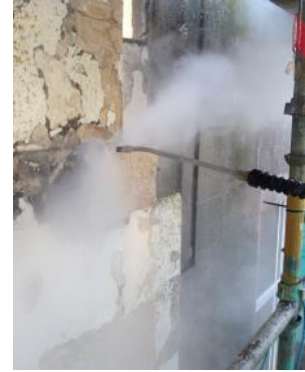
The DoFF System is a superheated water system (from Stonehealth) that uses a combination of low pressure and high temperature (up to 150°C) to remove ingrained dirt, biological matter and paint with minimal impact to the stone substrate (see photos right).

Granite Le Pelley proceeded to remove the paint with the DOFF system and proprietary paint softeners. As the main entrance of the shop had to be kept open, Granite Le Pelley installed a temporary system to cover the entrance, to protect the public and collected the waste water from the cleaning process above the entrance.

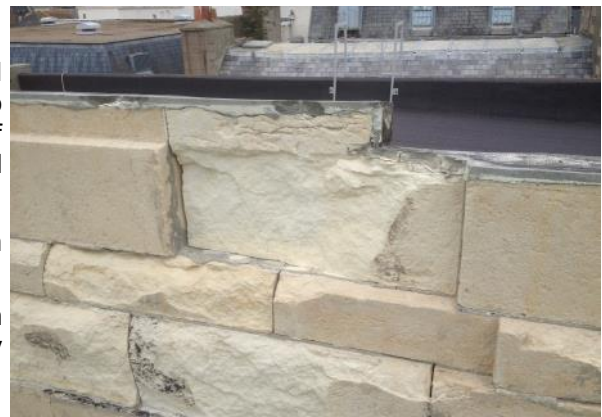
The stone façade was found to have some deterioration due to:

- Old bitumen and layers of impermeable modern paint had caused deterioration of the stone by preventing moisture egress from the wall,
- Hard cement pointing further limited the moisture from finding a way out of the building and had caused damage to the edge of the stone blocks,
- Rusty steel beam had caused damage to the upper elevation (by expanding),
- Water penetration through the various cracks increased the deterioration of the stone and steel beams,
- Poor previous repairs made with harder material (cement) had fallen out
- by delamination.

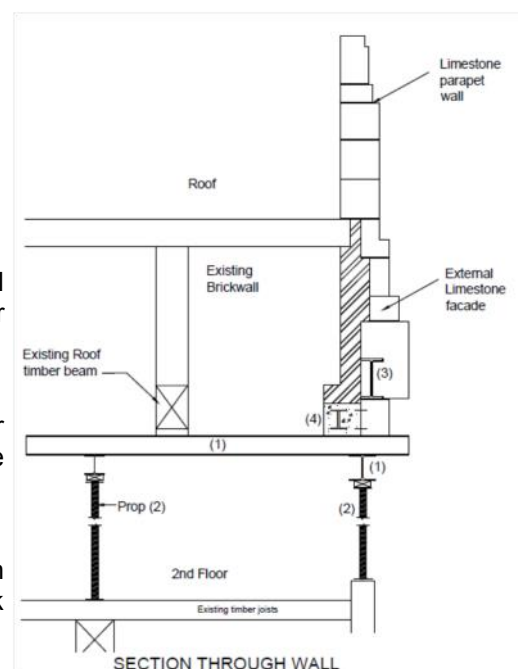
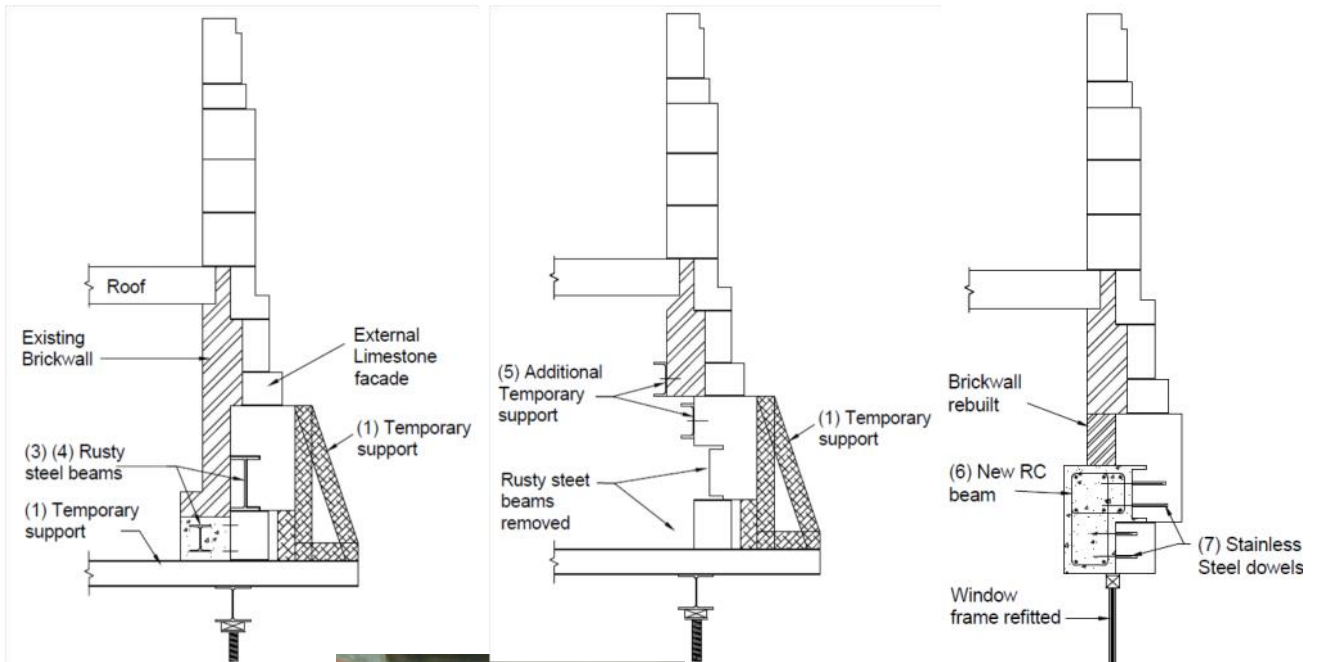
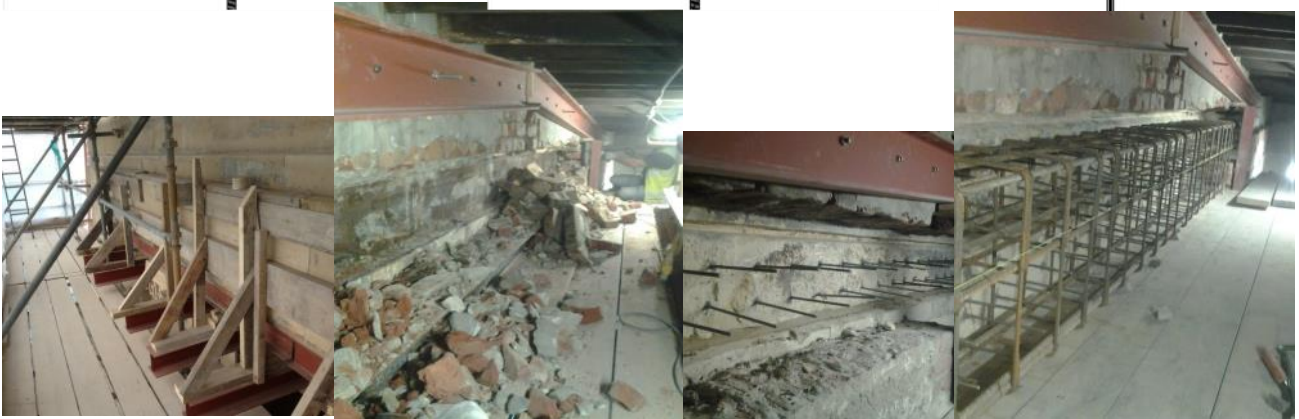
Granite Le Pelley assisted Structural Engineers, Ross Gower Associates in the investigation of the state of the elevation and then the development of a restoration method. The investigation revealed that two existing structural steel beams, supporting the upper elevation and the roof, were rusty and spalling which was causing the deterioration of the limestone façade. Granite Le Pelley then took great care to research the most suitable source of replacement stone.

Temporarily supporting the upper elevation using steel beams (1) and props (2) located below the 2nd floor lintels and above (5).

Removing the existing steel beams (3) & (4). Due to their weight (400kg) and length (8 meter), the steel beams were cut into several pieces before being removed.

Casting in-situ reinforced concrete beams (6) with previously resined in stainless steel dowels into the back of the stone (7).

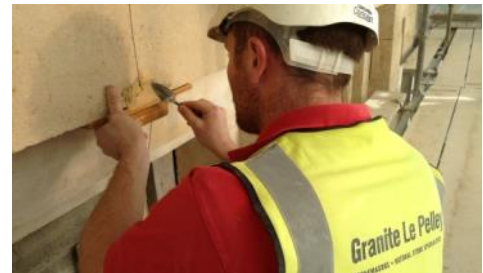
A. Plastic (mortar) Repairs

This method was used for small repairs, where the stone was exhibiting very friable, deteriorated surface but is otherwise sound without too much deep damage and completed by pinning where necessary.

This method consisted of digging out the repair to 20/35mm and installing stainless steel pins and wiring to secure the repair.

Squaring or undercutting the shoulders so as to provide a secure key and then applying specialist restoration repair mortar (4 colours used to match stone colour).

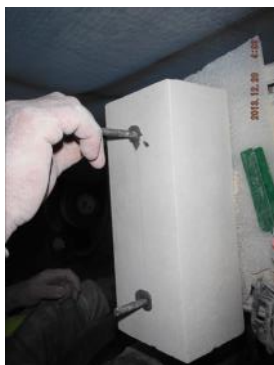
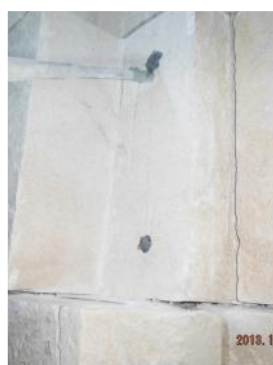
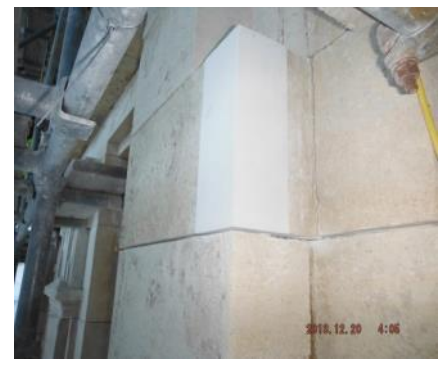
B. Replacement of Sections of Stone

This was undertaken where the stone had fallen away in larger chunks but there still remained the majority of the stone in place which was sound and stable and it was possible to 'indent' a new piece of stone, carefully sourced to match existing and to replace the missing portion.

The method consists of digging or cutting out the stone and then cutting a square 50mm depth new cladding piece, installed by pinning and grouting the back.

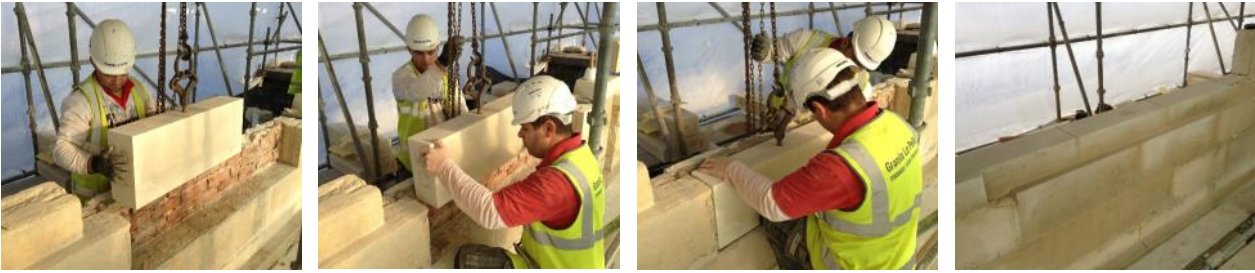
C. Replacement of Whole Sections of Stone

The parapet wall was in poor condition and a large section of wall had to be dismantled and replaced using new ashlar block.

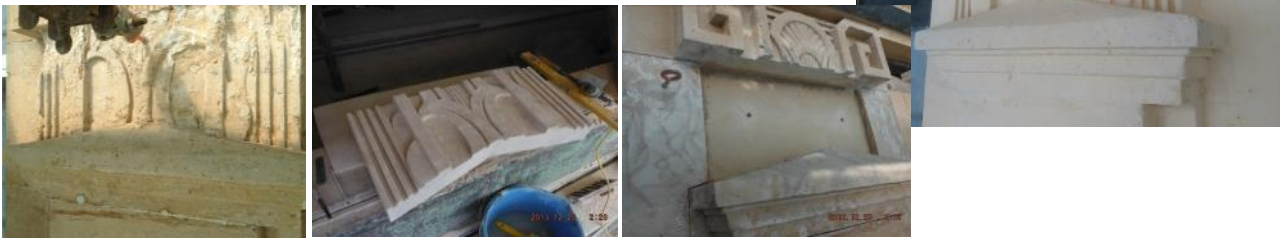
D. New Carved Stone

One of the existing carved stones was in a very poor condition and had to be replaced entirely. Mark Guest (Jersey Stonemason) reproduced a new carved stone copying the existing. The second carved stone was kept and partially repaired using mortar repair.
