## ST JAMES CHURCH, ST HELIER

### DESCRIPTION

Deep clean of the front towers using DOFF and TORC systems (from Stonehealth), careful disassembly of the failing elements of the pinnacles and then restoration of the pinnacles, extensive crack repair and localised repointing.

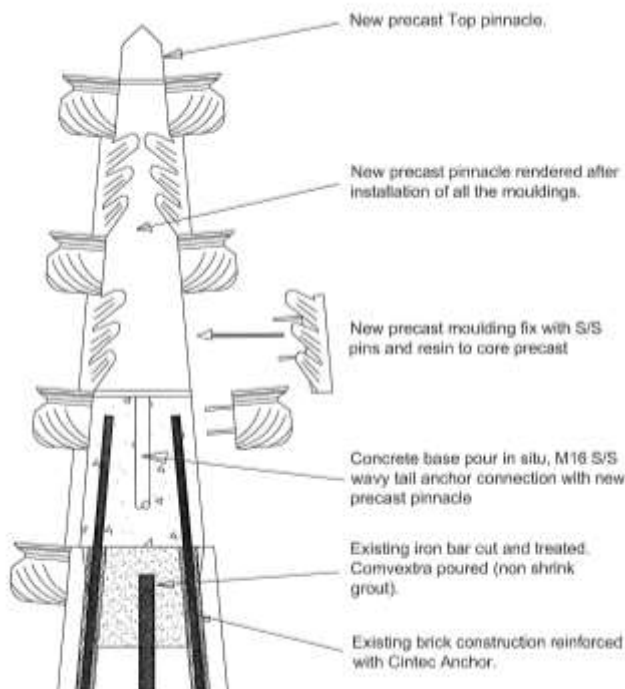
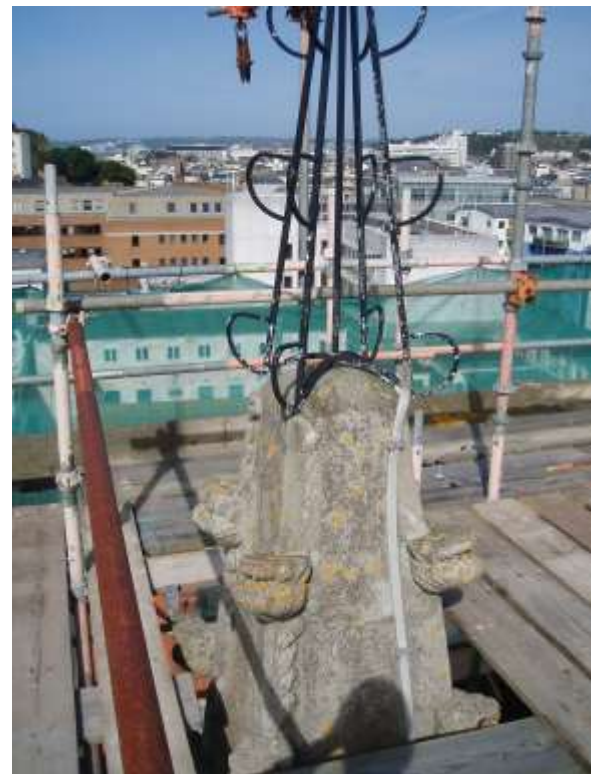
After the completion of the cleaning stage it was discovered that the 8 top pinnacles were in very bad condition and had to be structurally reinforced.

The pinnacles were reduced down (1) to 400mm. The existing iron bars were cut (2) and treated and the COMBEXTRA (non-shrinking grout) was poured. Then Cintec Anchors (3) were installed by Geomarine and the reinforced

concrete caps poured in-situ (4). Installation of the top precast piece then followed by resin anchoring a stainless steel bar into the cap (5), (lime: cement and sand (1:1:6)). Then the new cast mouldings were installed (6) and a final render coat applied over stainless steel mesh (7), (see photos 1-patric7)

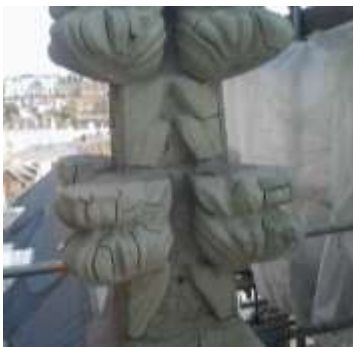
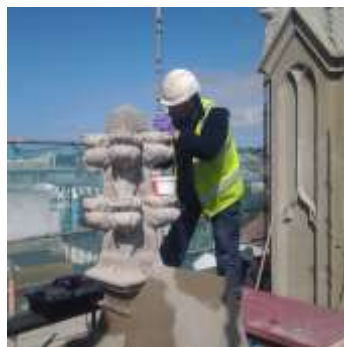
The central finial between the two towers on level 8 was in poor condition. There was extensive cracking and the top portion had fallen away. The structural engineer decided to keep the finial and re-stabilise it rather than replacing the entire portion. See photos left.

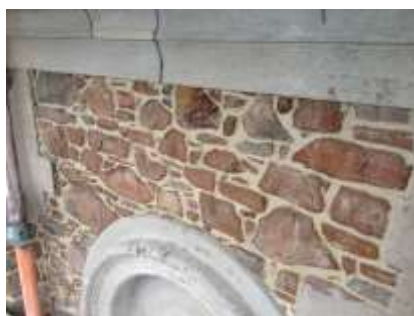
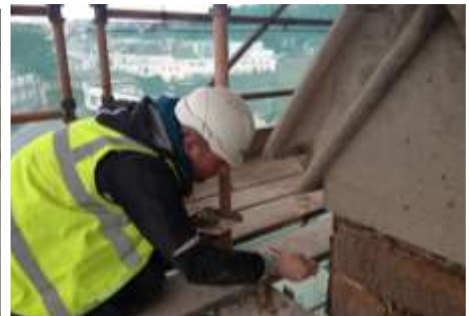
Throughout the masonry on the building there was extensive cracking of the render and cast elements.

The cracks were opened up with the use of die grinders (large dremels) to a width of approx. 10—20mm and a depth of 20-30mm. The shoulders of the cuts were left square with the surface and the debris cleaned out. The cuts were 'painted' with an epoxy primer consolidant. They were then, whilst the primer was still tacky, injected with thixotropic resin which sealed the crack and helped to knit the fabric together. They were then finished with a mouldable epoxy putty which was pressed into the cracks so that they finished flush. Beach sand was then pressed into the putty to blend them in with the surrounding render.

There was a small amount of repointing of the random granite wall (15%) using St Astier NHL 3.5 Lime and sharp sand (1:3).

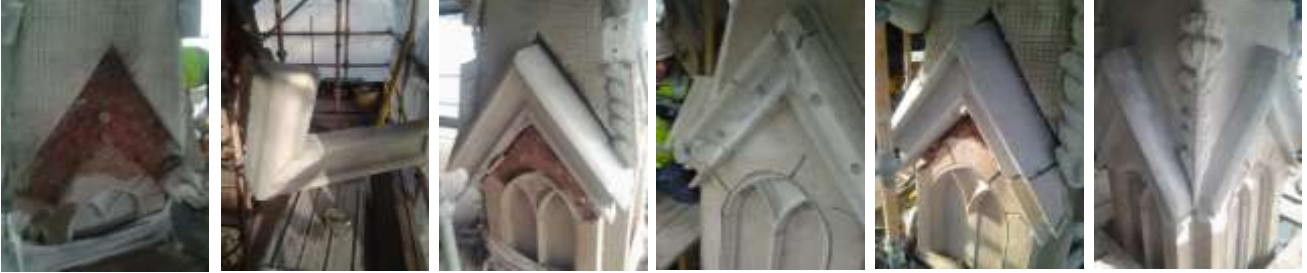
Found at the base of each of the pinnacle tops were four canopy mouldings which appeared to have originally comprised of four parts. The canopy mouldings presented a lot of cracks and some of them had completely fallen off. Presumably shrinkage cracks had deteriorated over time thereby permitting the ingress of water leading to further deterioration.

The canopies that had failed were replaced with new one-piece precast units, cast from one of the failed originals, which were “hung” from specially adapted Cintec anchors which connected to a stainless steel plate cast into the back of the pre-cast canopy (All designed by T & G Ltd). Once in place the piece was further restrained with a further two anchors. All the other existing canopies were also secured using Cintec Anchors

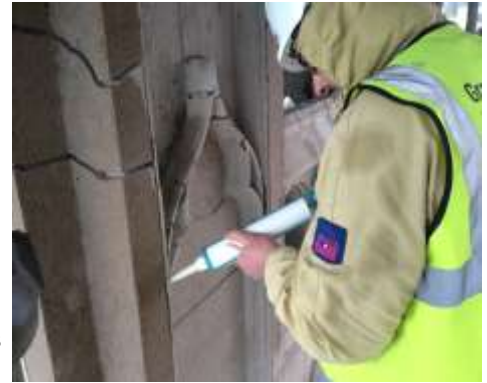
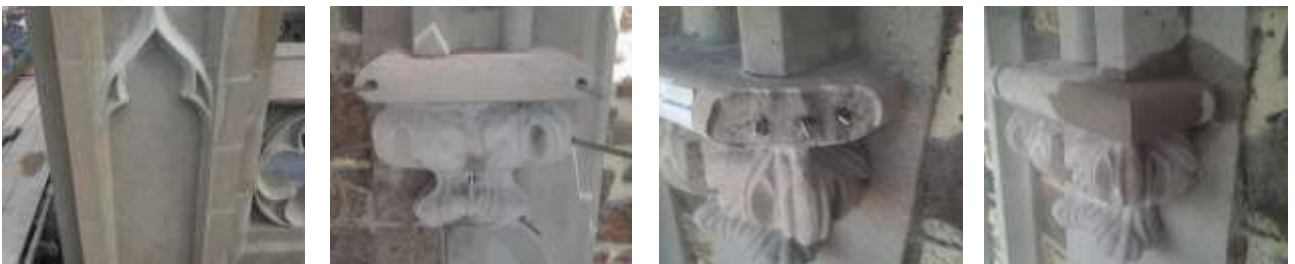
These exhibited a large amount of shrinkage cracking. On the side mouldings this was repaired through the prescribed crack repair method. In other places they were damaged by the spalling of steel wire reinforcement which had to be dug out, treated and repaired.

The cracks had their biggest impact on the tracery elements many of which had fallen away. These were replaced by new precast items that had 6mm stainless steel (A4) reinforcement and fixing pins cast into them that were then drilled and resin fixed in place with the joints being made with mouldable epoxy putty.
