NEW LOOK - 6 KING STREET, ST HELIER

CLIENT: NEW LOOK

CONTRACT ADMIN: ABS CONSULTANT LTD

ARCHITECT: ANTONY GIBB LTD

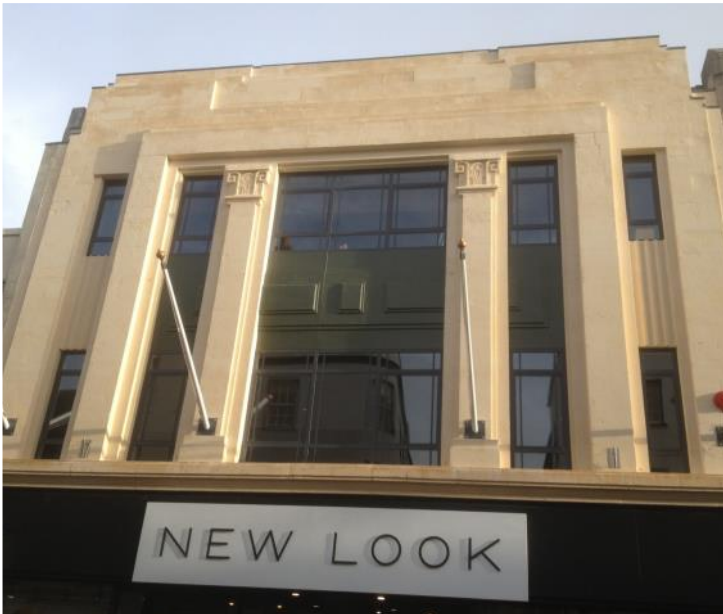
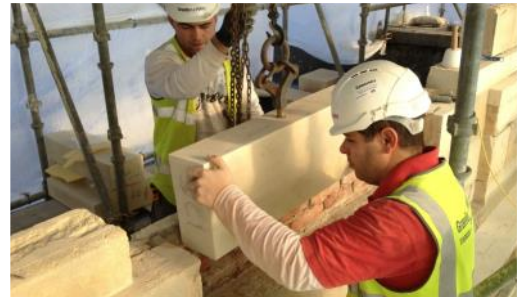
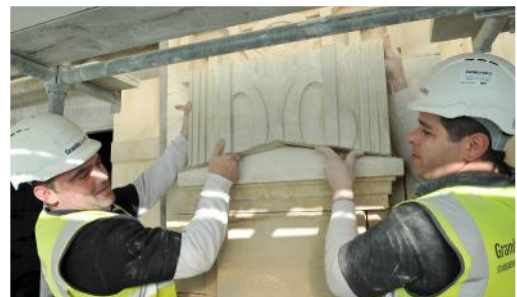
The historical document described the property as a good example of 1930c commercial house style consisting of a three storey five bay front south elevation. Originally the façade was described as rendered but after removal of the paint it was discovered to be possibly a unique example of an Art Deco Limestone Façade in Jersey.
